General Summary

The Study Watershed

Seven Mile Creek Watershed Nicollet County, Minnesota

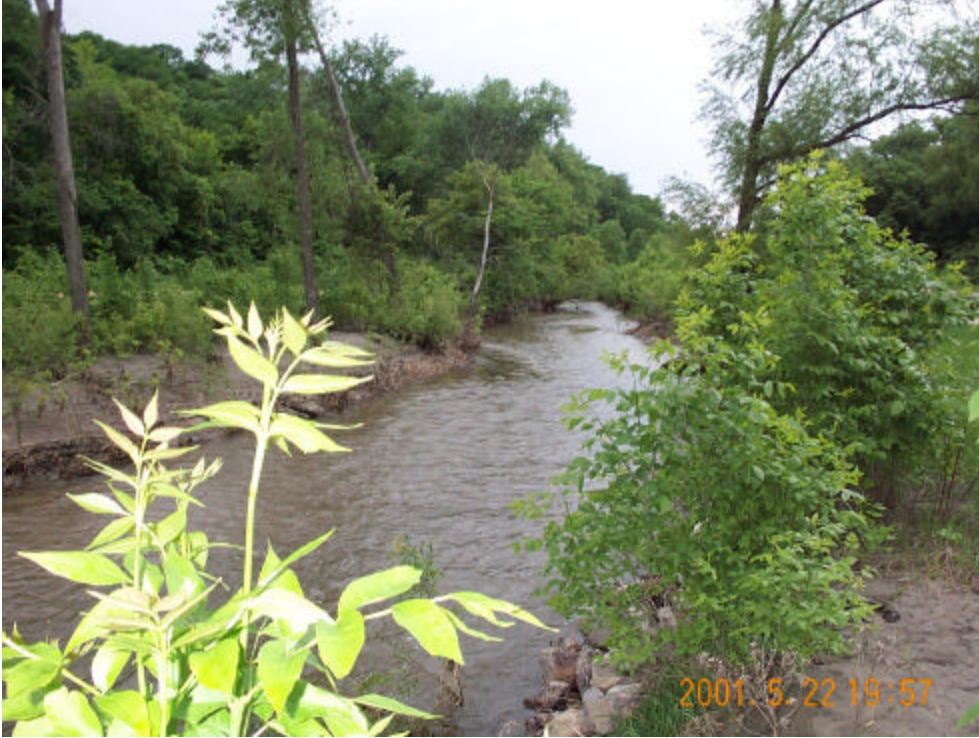
Photo 1. Seven Mile Creek near the mouth with Seven Mile Creek County Park. Much of the lower reach of creek is surrounded by sandstone bedrock outcrops and mature deciduous forest on steep ravines.

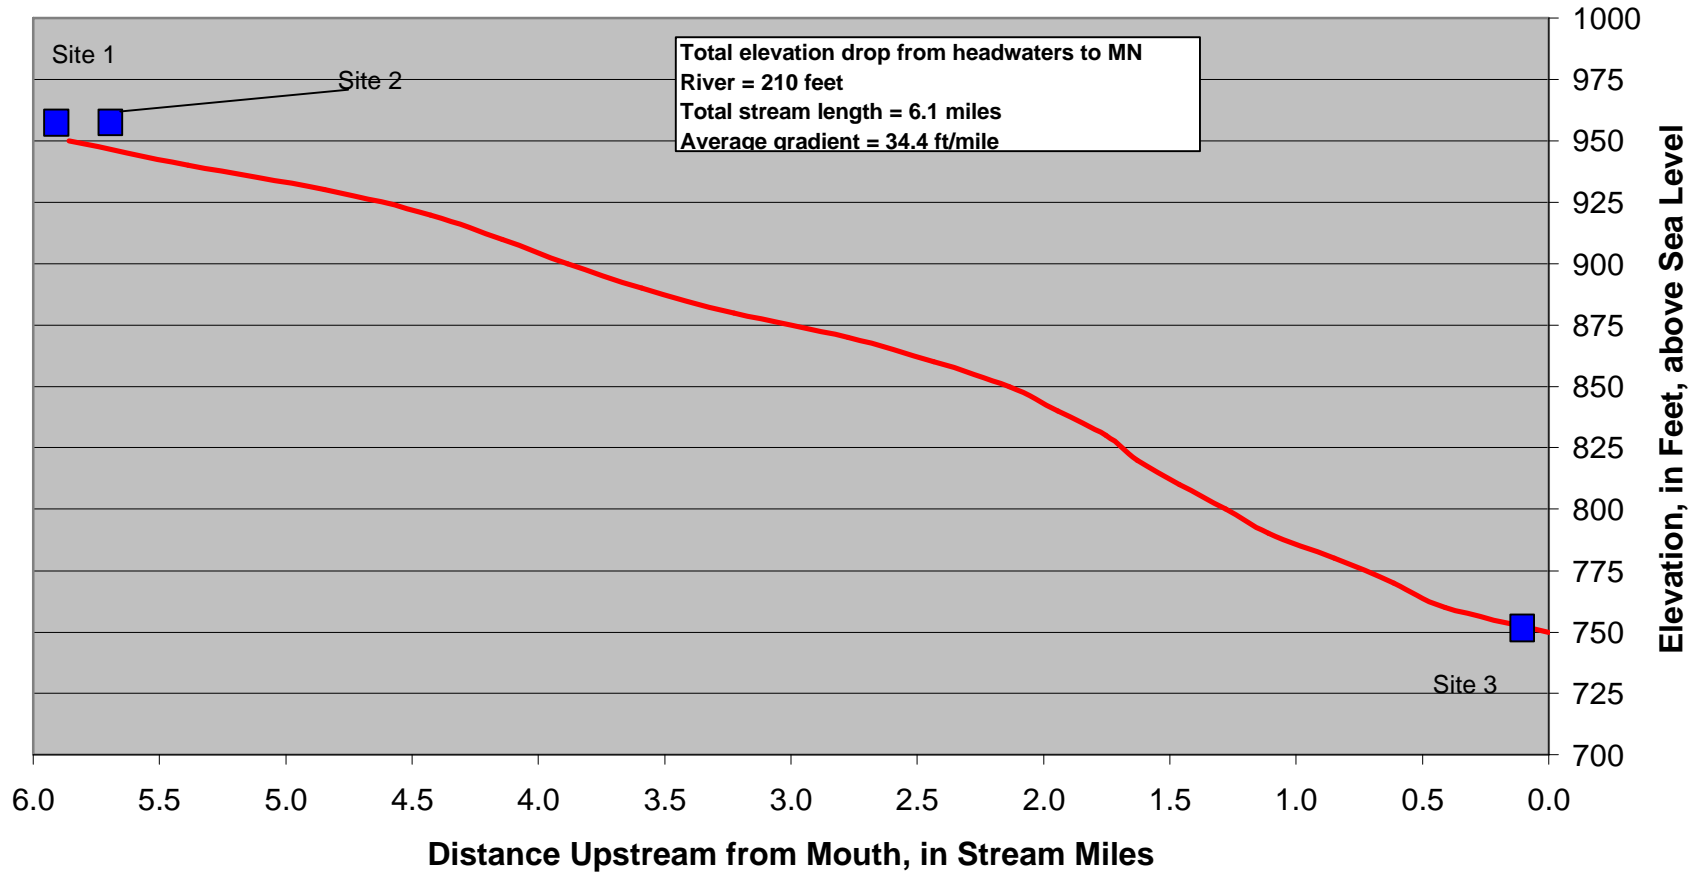
Water Surface Elevation by Stream Mile

Seven Mile Creek is 6.1 miles long and receives most of the drainage of the watershed from two constructed ditches. (CD 58 and CD 13). Elevation of the surface water starts at 1020 feet. Elevation of the creek at the mouth is 748 feet. Overall the river drops a total of 210 feet from monitoring site 1 to monitoring site 3 at the mouth with an average gradient of 34.4 feet/mile. Figure 1 shows a cross-sectional view of the creek's gradient from state highway 99 to the confluence of the MN River.

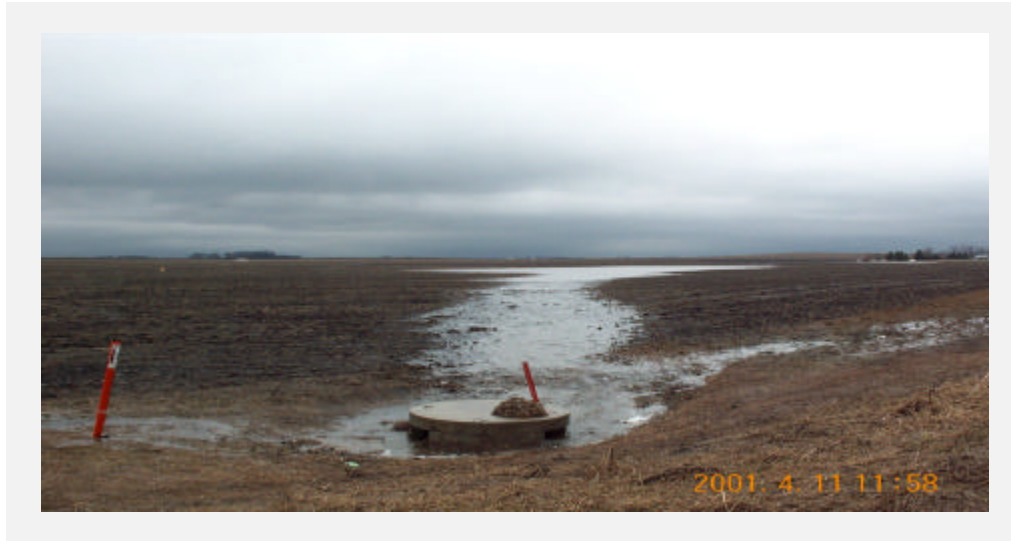
Photo 2. Spring runoff conditions within the watershed. It is estimated that approximately 70% of the pollutants in 2001 came through the watershed during the spring snowmelt conditions. Phosphorus was the dominant source of pollution within the watershed during the snowmelt conditions.

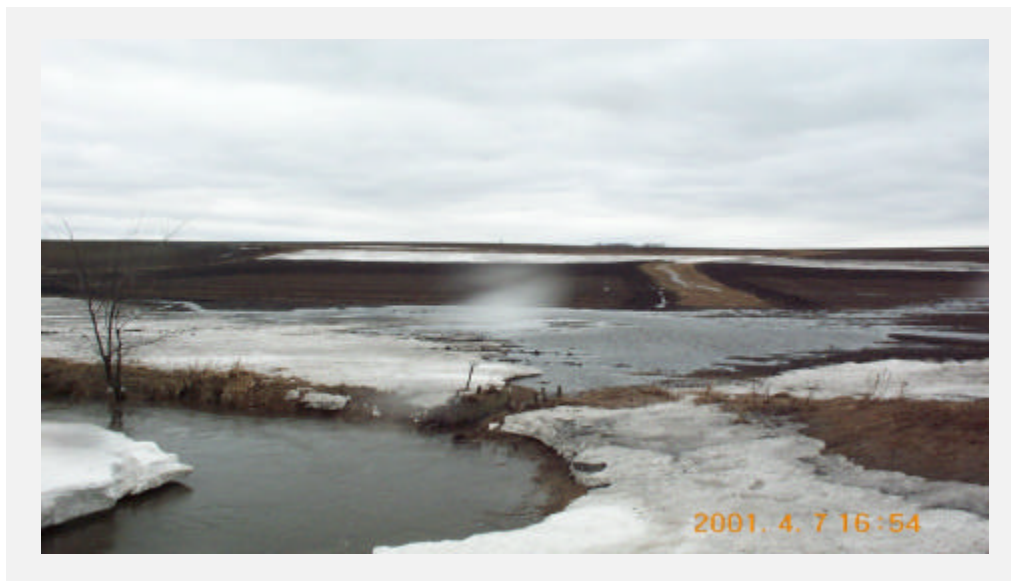
Photo 3. Snowmelt conditions at monitoring site 2 on April 7, 2001.

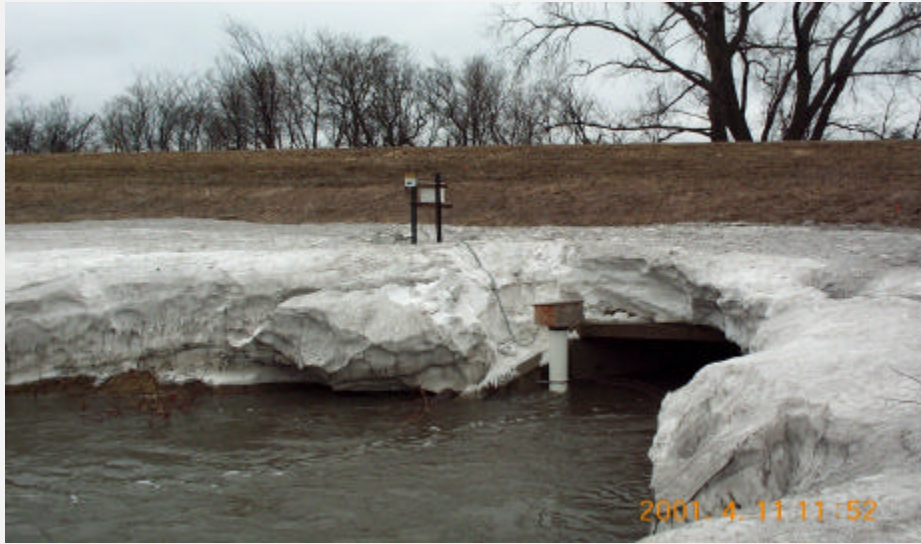
Photo 4. April 11, 2001. Spring runoff conditions at site 2. The monitoring sites had to be dug into the snow pack in order to capture the spring runoff conditions.
