WORKING WITH LANDOWNERS IN THE BLAKELEY RAVINES

Willie Peters Engineering Technician SWCD

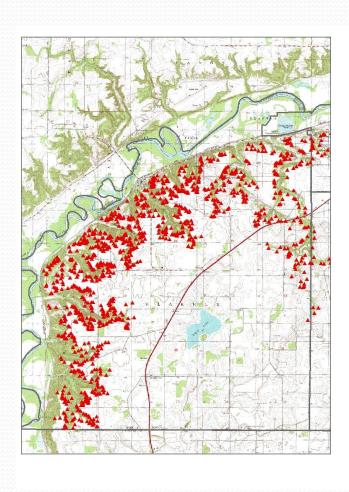
Targeting Landowners/Sites

- POTENTIAL STABILIZATION SITES IDENTIFIED THROUGH GIS
 - AERIAL PHOTOGRAPHY
 - LIDAR TWO-FOOT CONTOURS
 - PROPERTY BOUNDARIES
- MORE THAN 1200 POTENTIAL ERODING GULLY HEADS IDENTIFIED

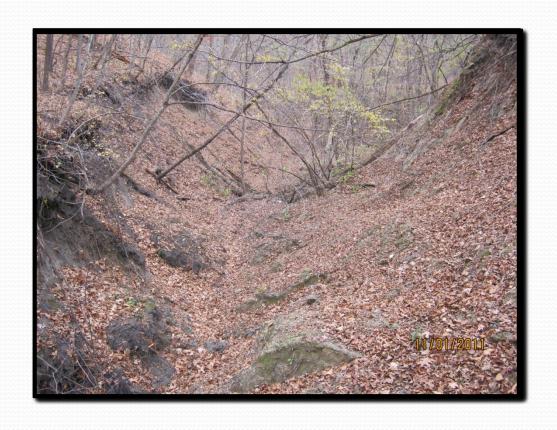
Site Visits With Landowners

What We Saw

- New Sites
- Old Structures
- Naturally Stabilized

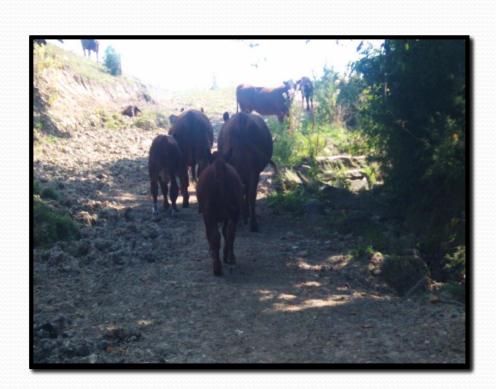
Typical Scenario

Farmer Suffering Significant Erosion at Ravine Head

- Seeps
- Woods Road
- Livestock Cattle Access
- 260' Drop to MN River

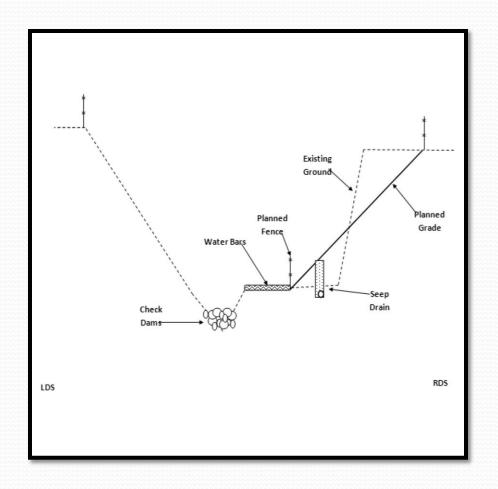
Typical Scenario

Corrective Measures

- WASCB at Gully Head
- Livestock Exclusion
- Check Dams in Ravine
- Water Bars in Road
- Subsurface Drainage
- Slope Stabilization

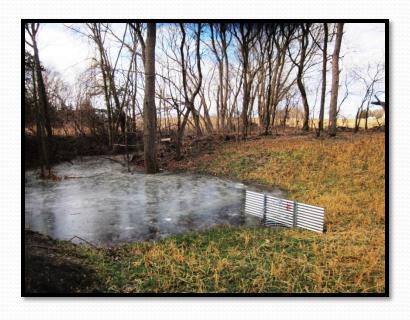
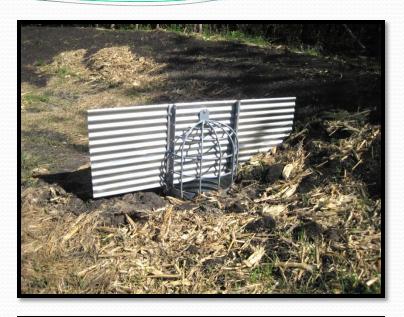
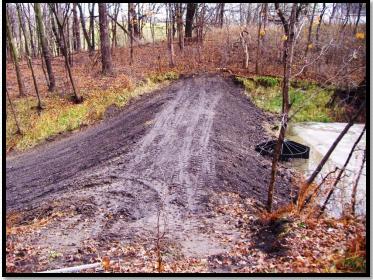
- Control Grade at Head-Cut
- Doesn't Reduce Peak Rates
- Wet vs Dry

- Hooded Inlet (pipe) Structures
- Water & Sediment Basin Type Structures
- Vertical Riser Structures
- Chutes
- Critical Area Shaping

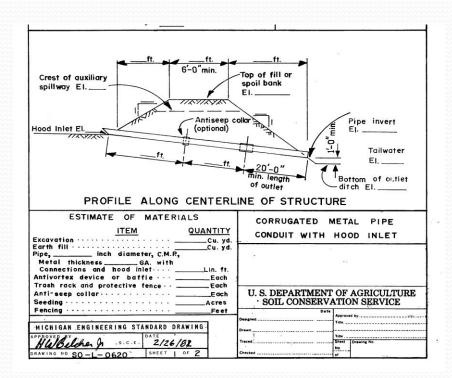
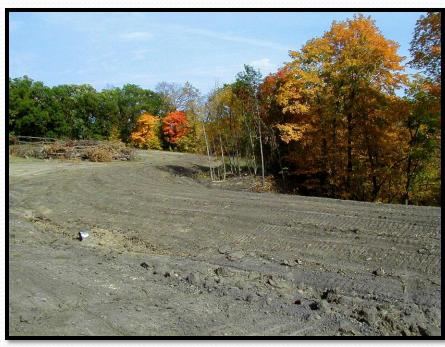
Hooded Inlet Structures

- Control Grade at Head-Cut
- Doesn't Reduce Peak Rates
- Less Expensive

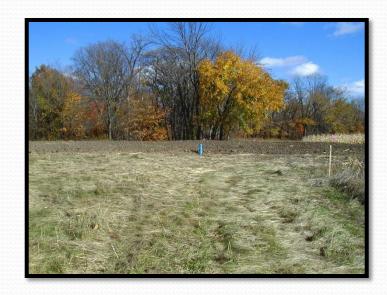
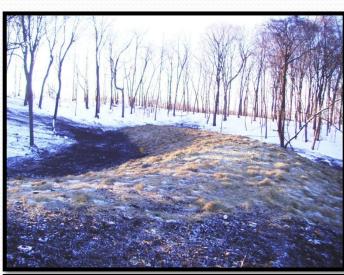
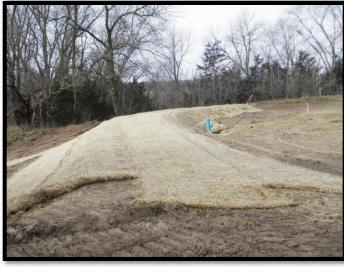
Water & Sediment Basins

- Relatively Inexpensive
- Reduces Discharge Rates

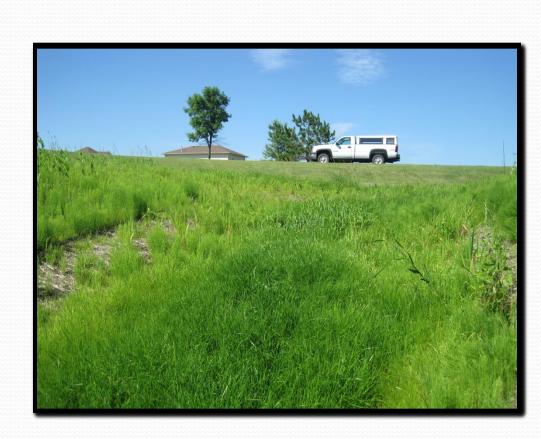
Chutes (vegetated)

- Least Expensive
- Limited Use
- Hold Up Well

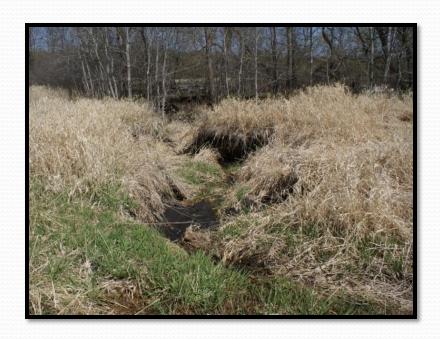
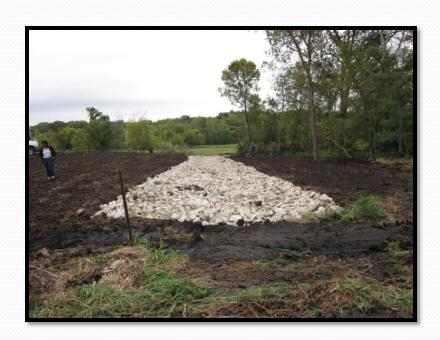
Chutes (rock riprap)

- Costly
- Limestone Weathering Issues
- Easy to Construct

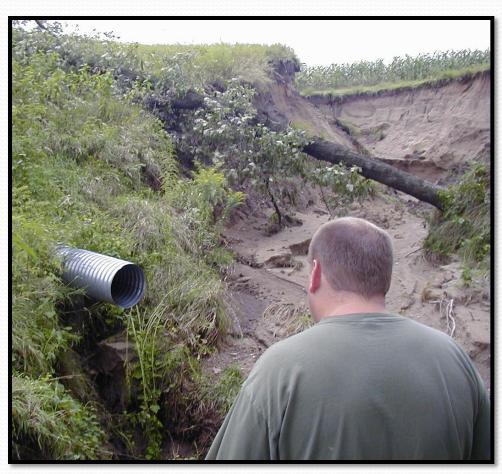
Attempting
Emergency
Spillways Where
They Don't belong

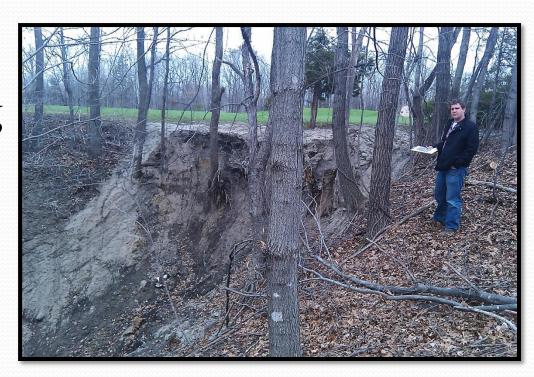
Landowner Fixing by Filling
